TOBU TOWER SKYTREE Co., Ltd.

Investigation Results and Recurrence Prevention Measures Regarding the Entrapment  
Incident (Occurred on February 22) Caused by the Stoppage of Tokyo Skytree®  
Observation Deck Elevator.

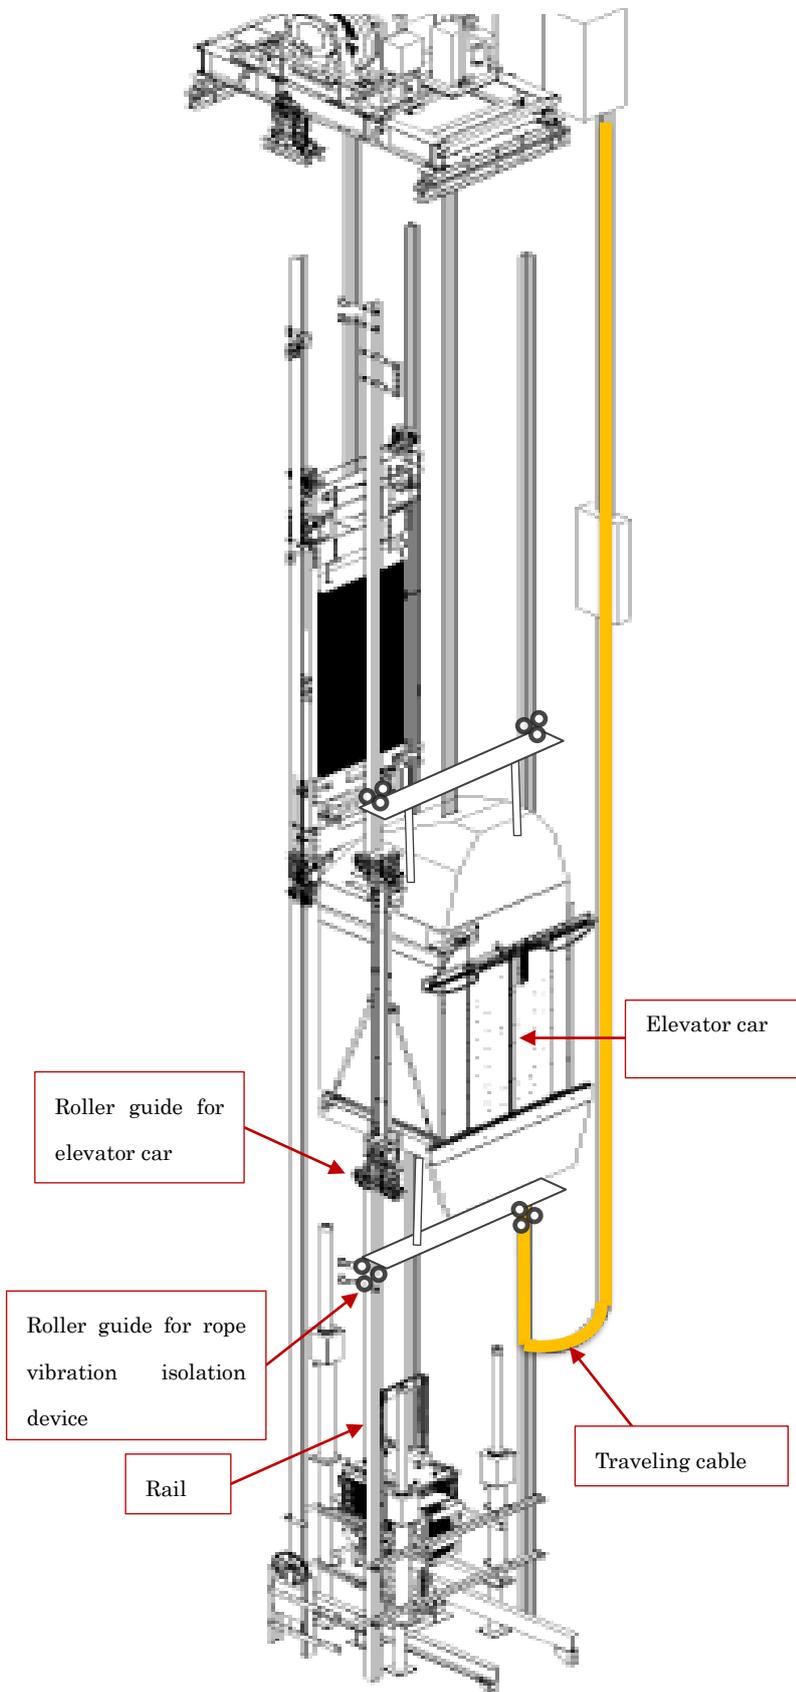
Overall Elevator Drawing

The entrapment incident in the Winter Elevator occurred because the traveling cable connecting the elevator's control panel to the elevator car became caught in the rotating section of the guide device (roller guide) that enables the elevator to move along its rails.

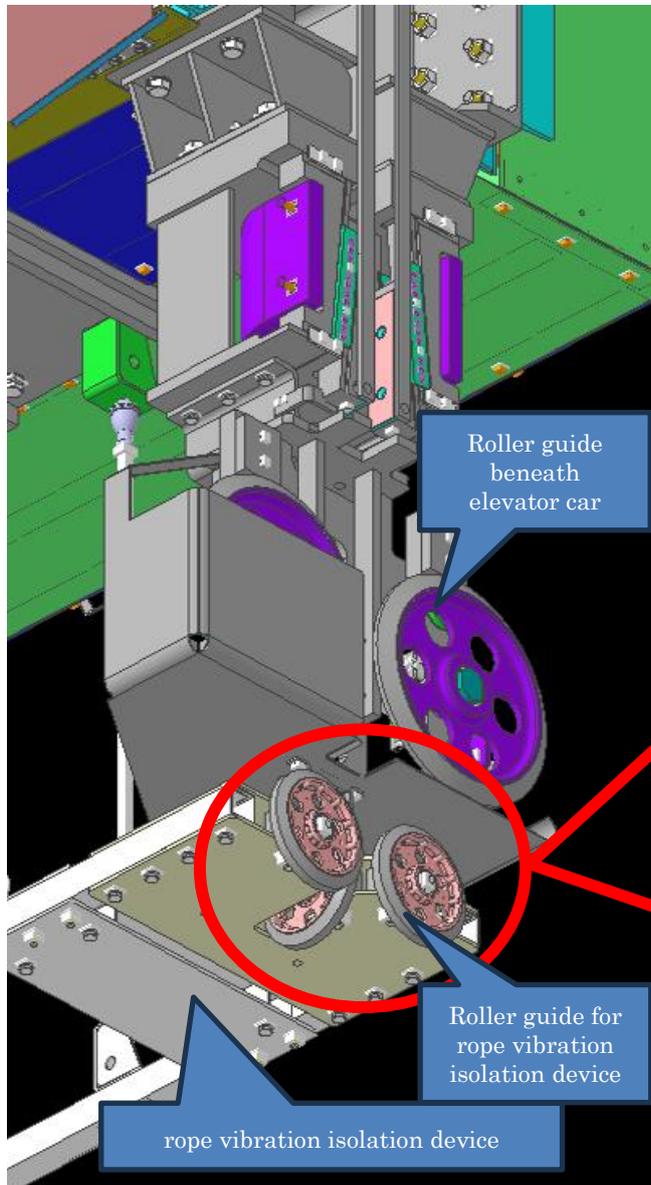
■ Before measures

Factor 3: Absence of a protective cover on the roller guide section of the rope vibration isolation device located beneath the elevator car.

Normally, the traveling cable does not come into contact with the roller guide beneath the elevator car. However, as a precaution, a protective cover is installed over the roller guide to prevent the traveling cable from making contact with it during significant sway, such as in strong winds.

The Winter Elevator, however, has a customized specification that includes a "rope

vibration isolation device” \*2 mounted beneath the car. This device also features a roller guide that runs along the rail, but no protective cover had been installed on it. As a result, if the traveling cable were to sway significantly due to strong winds or other factors, it is possible that the travel cable could come into contact with the roller guide of the rope vibration isolation device.

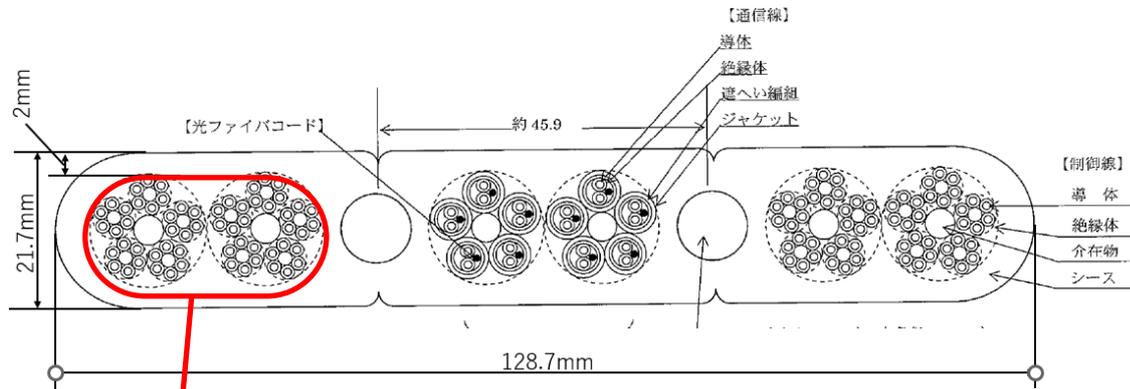
【Structure of the Traveling Cable (Cross-Section)】

It was also confirmed that the damage to the internal wiring included damage to the intercom line, which prevented the Disaster Control Center from communicating with the guests inside the elevator.

Damaged Lines:  
 Safety circuit line  
 Control signal line  
 Intercom line

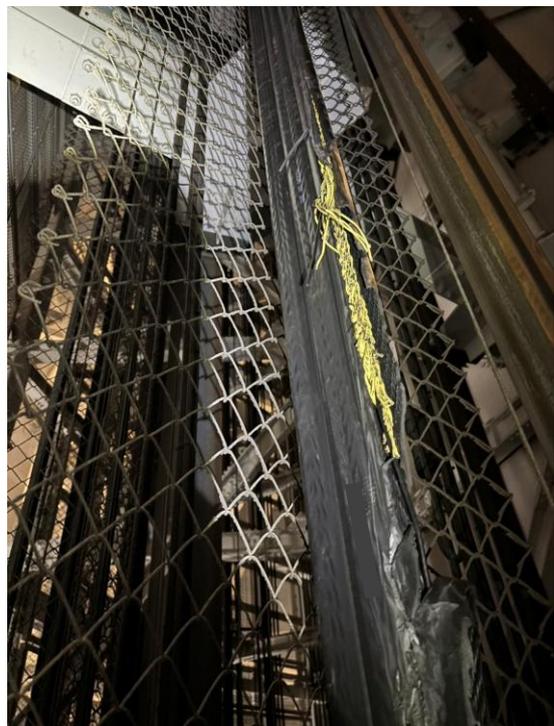
Damaged Travel Cable

The reason the fuse inside the control panel blew was that the traveling cable \*1 of the Winter Elevator became caught in the roller guide of the “rope vibration isolation device” \*2 installed beneath the elevator. This caused the cable’s outer insulation to be stripped, damaging the internal wiring and resulting in a ground fault.

As a result, the cable's outer insulation was stripped, the internal wiring was damaged, and a ground fault occurred, triggering an emergency stop. This subsequently hindered the rescue operation.

Regarding the Winter Elevator, we will continue inspections, including replacement of the traveling cable and related components.
