TOBU TOWER SKYTREE Co., Ltd.

Investigation Results and Recurrence Prevention Measures Regarding the Entrapment  
Incident (Occurred on February 22) Caused by the Stoppage of Tokyo Skytree®  
Observation Deck Elevator.

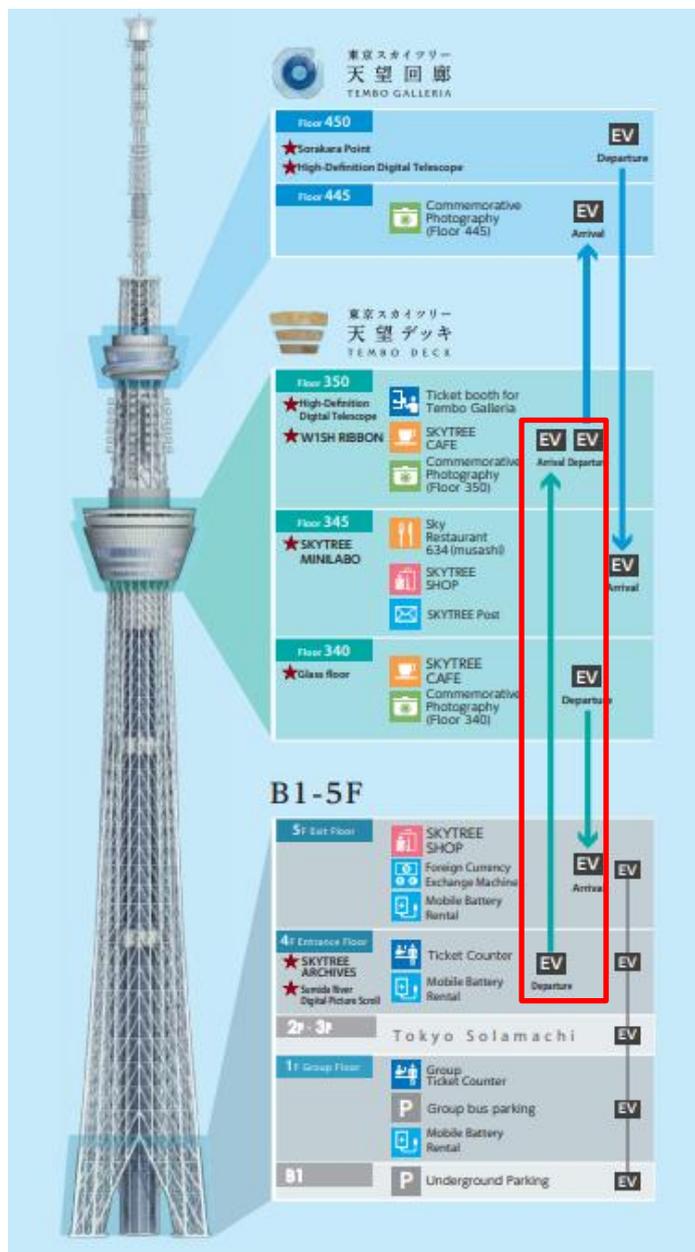
Due to *Factor 3*, the already twisted traveling cable came into contact with the roller guide of the rope vibration isolation device beneath the elevator car and was drawn into it. Therefore, the movement of the traveling cable became restricted and it came into contact with the elevator car. As a result, the outer insulation was stripped, the internal wiring was damaged, and a ground fault occurred, causing the malfunction.

Based on Estimations 1 to 3, we concluded that the insulation of the Winter Elevator’s traveling cable was stripped, the internal wiring was damaged, and a ground fault occurred, resulting in both elevators coming to a stop.

Damaged Lines:  
 Safety circuit line  
 Control signal line  
 Intercom line

【Damage Status of the Traveling Cable in the Winter Elevator】

Damaged Travel Cable

Regarding the Winter Elevator, we will continue inspections, including replacement of the traveling cable and related components.
